Eliminate Your Corrosion and Wear Problems... The AEGIS Way

AEGIS Tungsten

Case Study: Secondary Superheater Tube Wastage

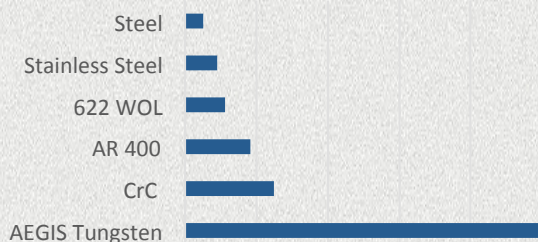
Relative Life of Common Materials
In wear applications

Tungsten performs exceptionally well in abrasive wear and high temperature erosion conditions; extending the useful

life of components by as much as 20 times (or more) that of unprotected parts.

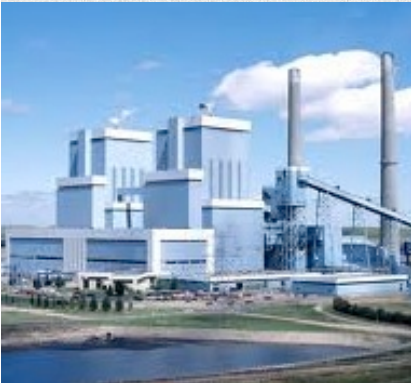
Laser Cladding - Tube Interface

Laser Cladding - Uniform thickness:
Easier to clean, better heat transfer

Customer requested configuration:
22' loose tube with weld overlay

AEGIS recommendation:
22' loose tube with three 3' targeted
sections of laser clad using higher
hardness material

A Utility power plant was experiencing on-going wastage of the leading edge superheater tubes in a 400 MW boiler. The plant had requested replacement tubes with a weld overlay coating over the length of the 22' long tube.

AEGIS Approach: (AEGIS Determined Cause - *Sootblower Erosion*)
